PRELIMINARY ASSESSMENT

THE COLD STREAM WATERSHED

A tributary of the Little Truckee River

October 2010

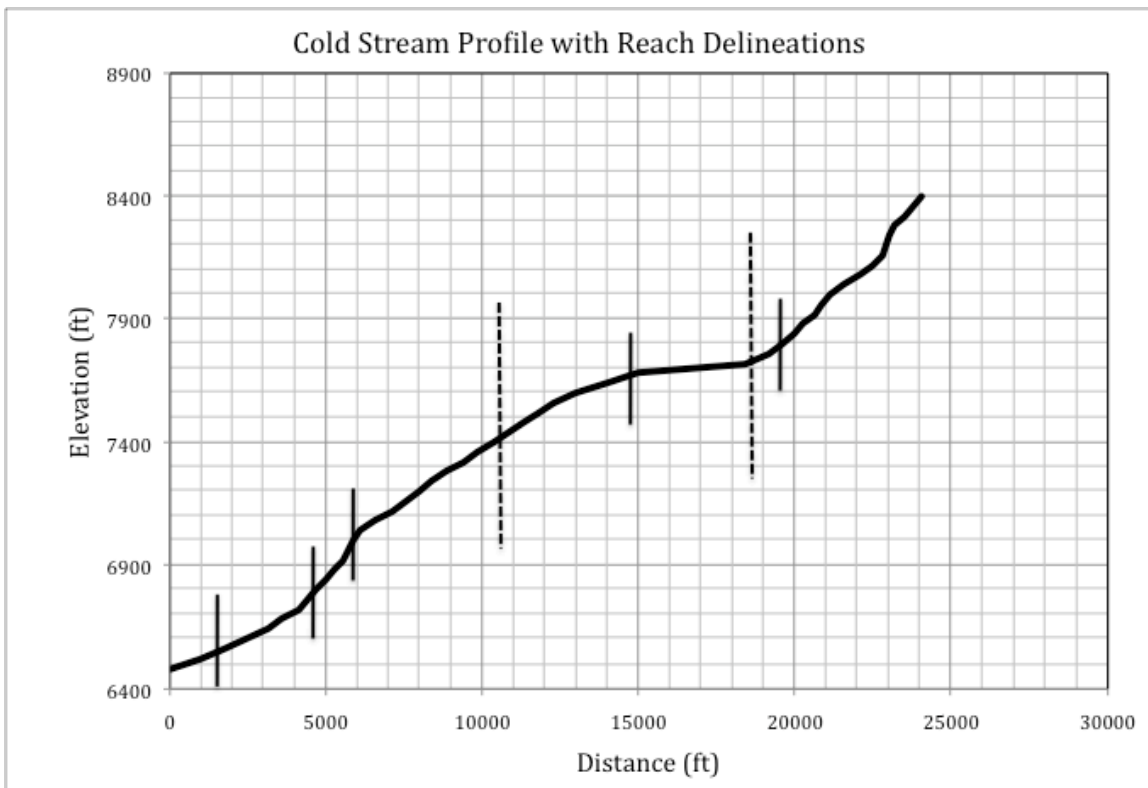
Figure 2

Taken together, the information gathered from these two surveys depict a high-energy channel, still working to adjust its profile as it cuts through layers of glacial material. The stream profile shown below depicts an unusual convex profile through reach 4 indicating a large volume of valley fill and resistant substrate.

Solid vertical lines indicate 2010 reach delineations. Dashed lines show reach delineations from 2000 USFS survey

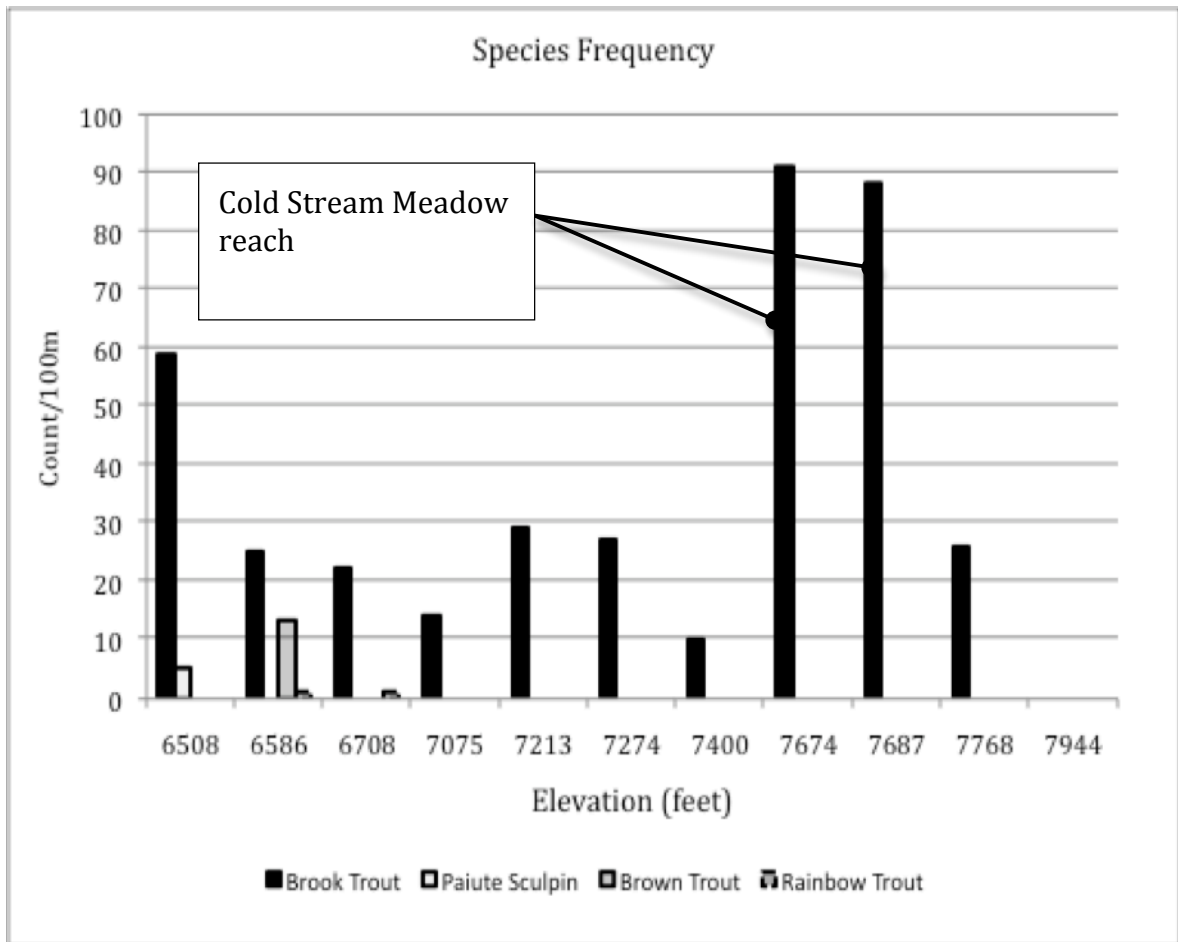
Figure 3: Fish survey results by transect elevation

Brook trout clearly dominate the stream as a whole. Sculpin, Brown trout and Rainbow trout were all found in very low numbers, all below the high gradient section that begins around 6800'. The highest densities of Brook trout were found in the lowest gradient reaches that include the alluvial fan (reach 1) and the Cold Stream Meadow (reach 5). One plausible scenario is that Cold Stream Meadow is something of a fish "nursery" that supplies the rest of the system through downstream migration and that the rigors of the high gradient reaches below limit the upstream advance of competing salmonids.

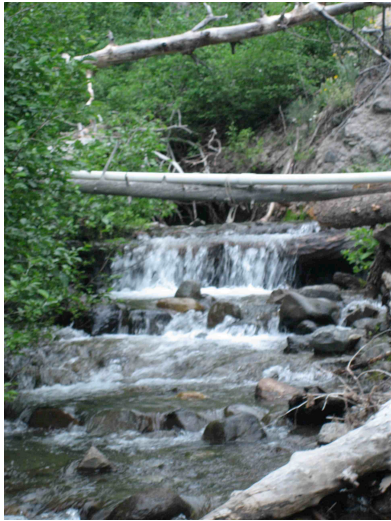
TOP/BOTTOM LEFT highlights the role of log steps in pool formation and bedload retention in the high gradient reach. TOP RIGHT: Bedrock chute through reach 3. BOTTOM RIGHT: Landslides flanking channel in reach 3
